POTENTIAL HAZARDOUS WASTE SITE

Magnus Chemical Co.	NJD980530265
Site Name	EPA Site ID Number
605 South Avenue	02-8301-34
Garwood, NJ 07027	
Address	TDD Number

Date of Site Visit: 3/4/83

POTENTIAL HAZARDOUS WASTE SITE
SITE INSPECTION REPORT
PART 1 - SITE LOCATION AND INSPECTION INFORMATION

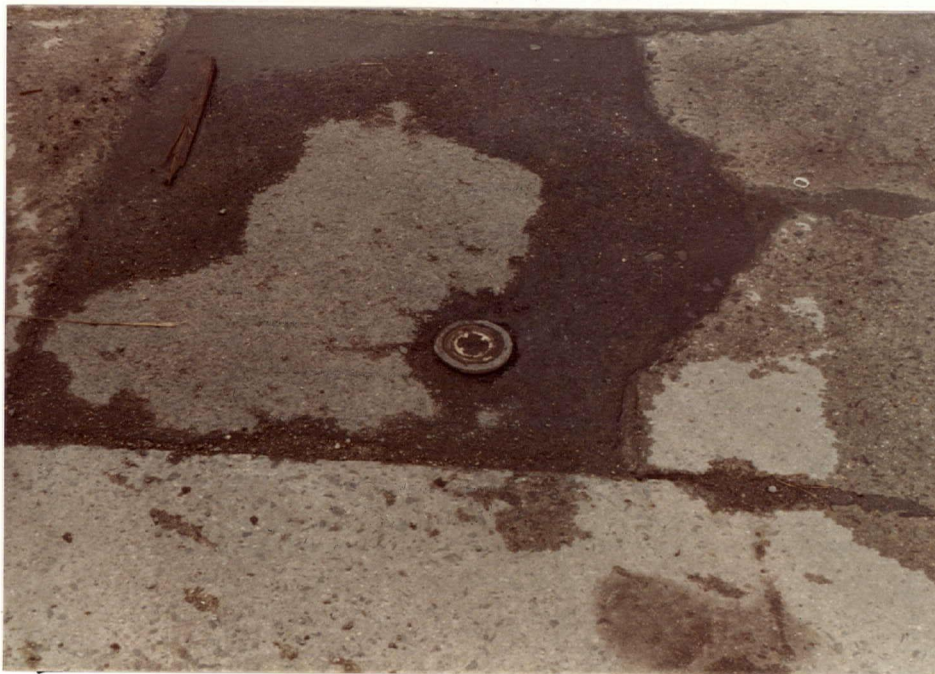
There are 4 or 5 underground storage tanks on site. The age, integrity and contents of the tanks are unknown. At one time the contents of the tanks in question were as follows: One 10,000 gallon tank of caustic liquid potash; one 10,000 gallon tank of fuel oil; two 10,000 gallon tanks of cresylic acid 554; one 10,000 gallon tank of kerosene.

1. Fill cap for #1 underground storage tank. Magnus Chemical Co., Garwood, N.J., 3/4/83, 11:04 a.m.

Since the contents and integrity of the underground storage tanks is not known, the potential for groundwater contamination exists. It is recommended that the existing tanks be sampled, and the tanks structural integrity be determined.

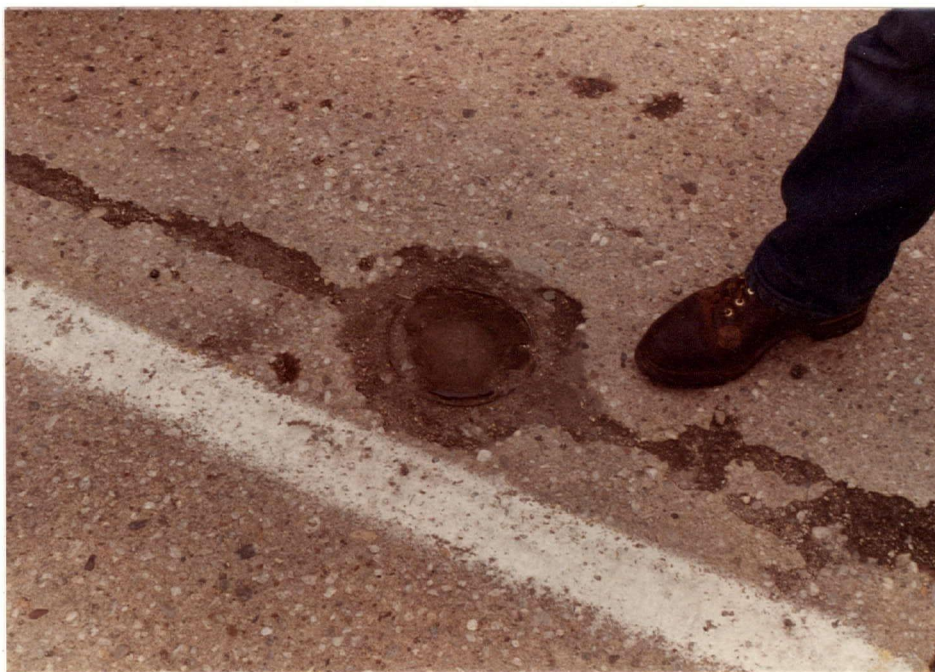
2. Fill cap for #2 underground storage tank. Magnus Chemical Co., Garwood, N.J., 3/4/83, 11:04 a.m.

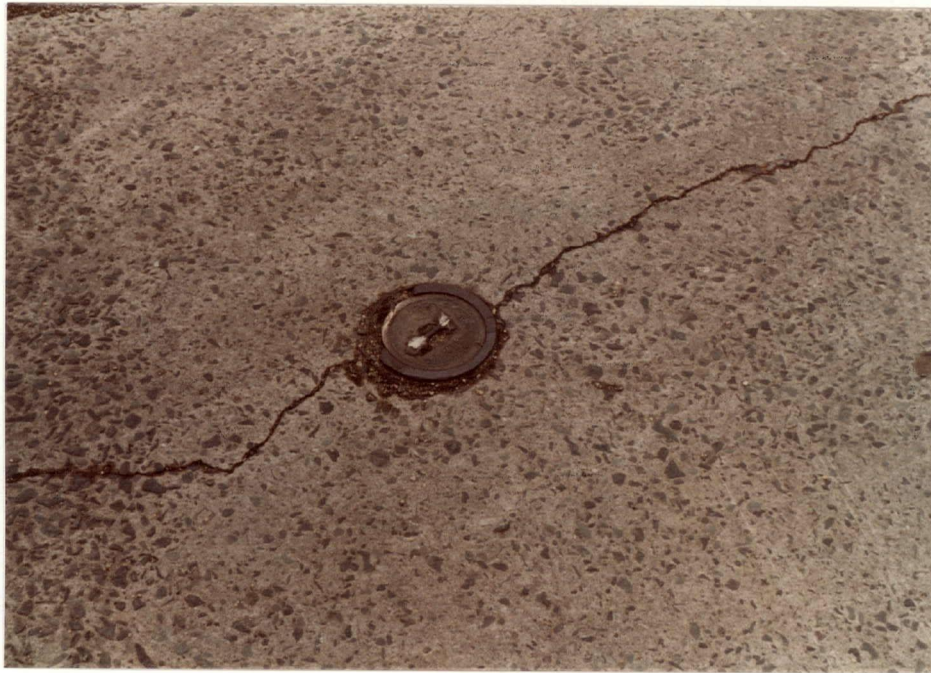
3. Fill cap for #3 underground storage tank. Magnus Chemical Co., Garwood, N.J., 3/4/83, 11:04 a.m.

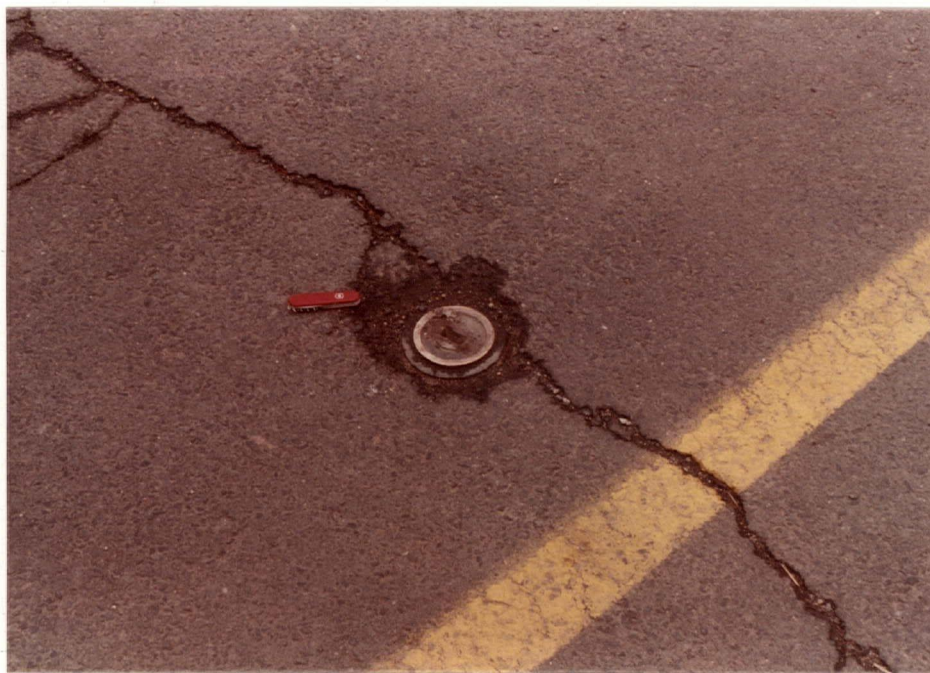
4. Fill cap for #4 underground storage tank. Magnus Chemical Co., Garwood, N.J., 3/4/83, 11:04 a.m.

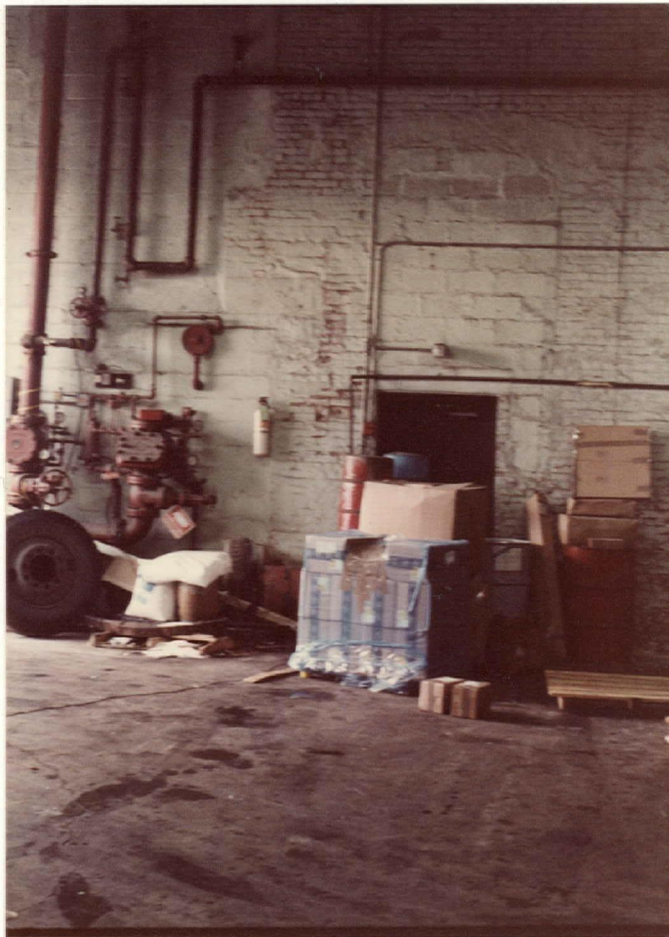
According to Charles Piscitelli, who worked for the Bell Factory terminal on the renovation of 608 South Avenue in 1971, all of the tanks on the property except four or five of the underground storage tanks were removed. In 1975, 608 South Avenue was sold by the Bell Factory terminal to ACP Trust. The site is currently owned by ACP Trust and subleased to various companies. None of the current tenant's handle or store any hazardous materials other than fuel oil. Four or five underground storage tanks still remain on the site. According to Charles Piscitelli, Warehouse Manager for ACP Trust, the integrity and content of these four or five underground tanks are not known. There were no above ground tanks or drums observed during the NUS FIT II Site Inspection, 3/4/83.

5. View of former location of above-ground, indoor storage tanks. Magnus Chemical Co., Garwood, N.J., 3/4/83, 11:00 a.m.

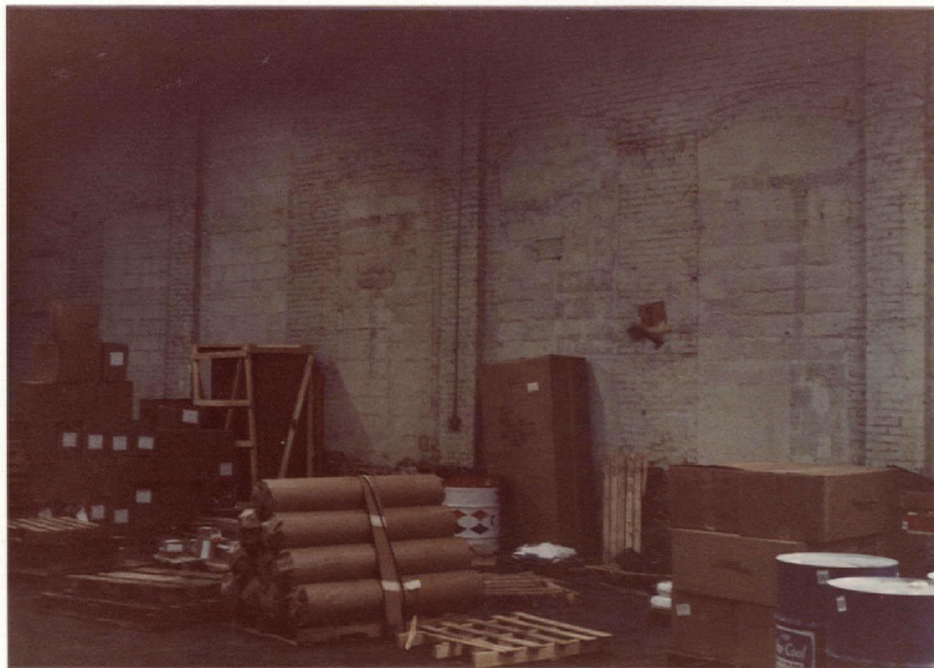
6. View of former location of above-ground, indoor storage tanks. Magnus Chemical Co., Garwood, N.J., 3/4/83, 11:00 a.m.
